Water Compliance Inspection Report

***NPDES
Inspection Report***

***Vander Haak Dairy, LLC
Lynden, WA***

***Dustan Bott
Environmental Protection Agency, Region 10
Office of Compliance and Enforcement
Inspection and Enforcement Management Unit***

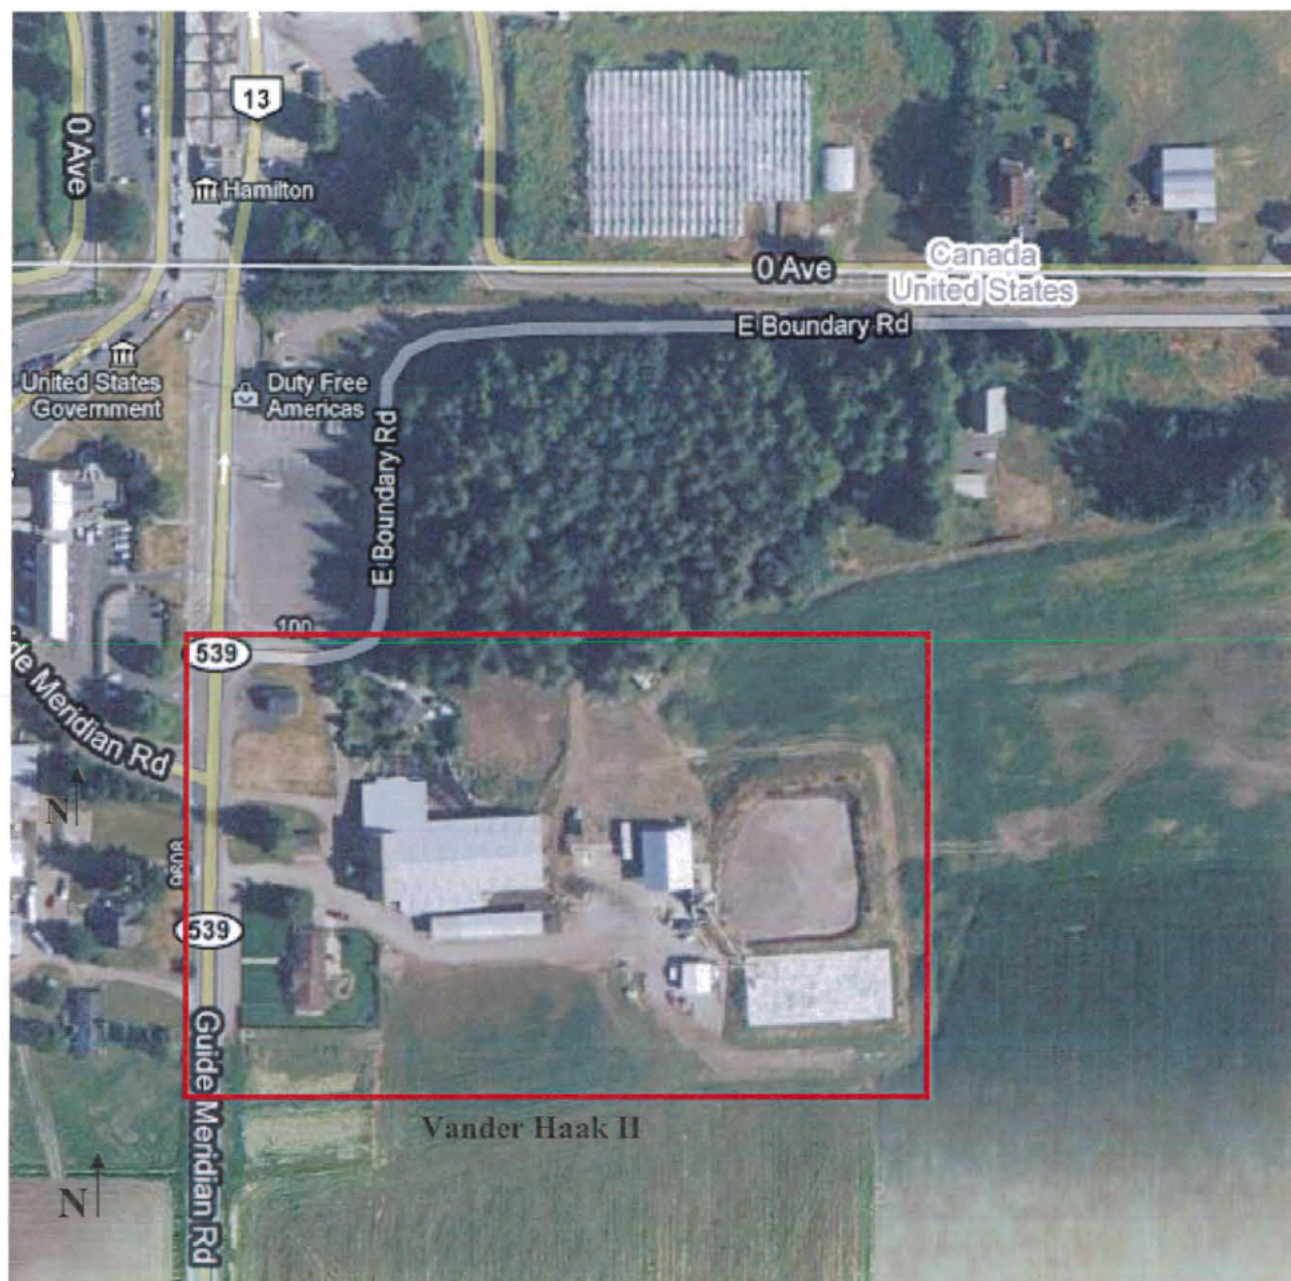
Photo 3. This is an aerial photo from Google of the Vander Haak II lagoon and digester location.

The Vander Haak II site is located on the east side of Guide Meridian Road just south of the U.S. and Canada border crossing (See photos 1 and 3 in Attachment A). Approximately 60 dry cows are confined here, and the confinement areas are scraped once daily. The Dairy installed a digester at this location, and the majority of manure they generate is processed through this digester. The manure is processed through the digester in a 22 day cycle. This generates electricity that is sold to the power company and the Dairy then buys back the power they need. Once the manure is processed through the digester it goes to the solid separator at this location, and then stored in the lagoon here. The processed waste in the Vander Haak II lagoon is then transported via underground pipes to three of their lagoons- Casey's, Leender's, and Vander Haak I. It is then land applied from these locations.

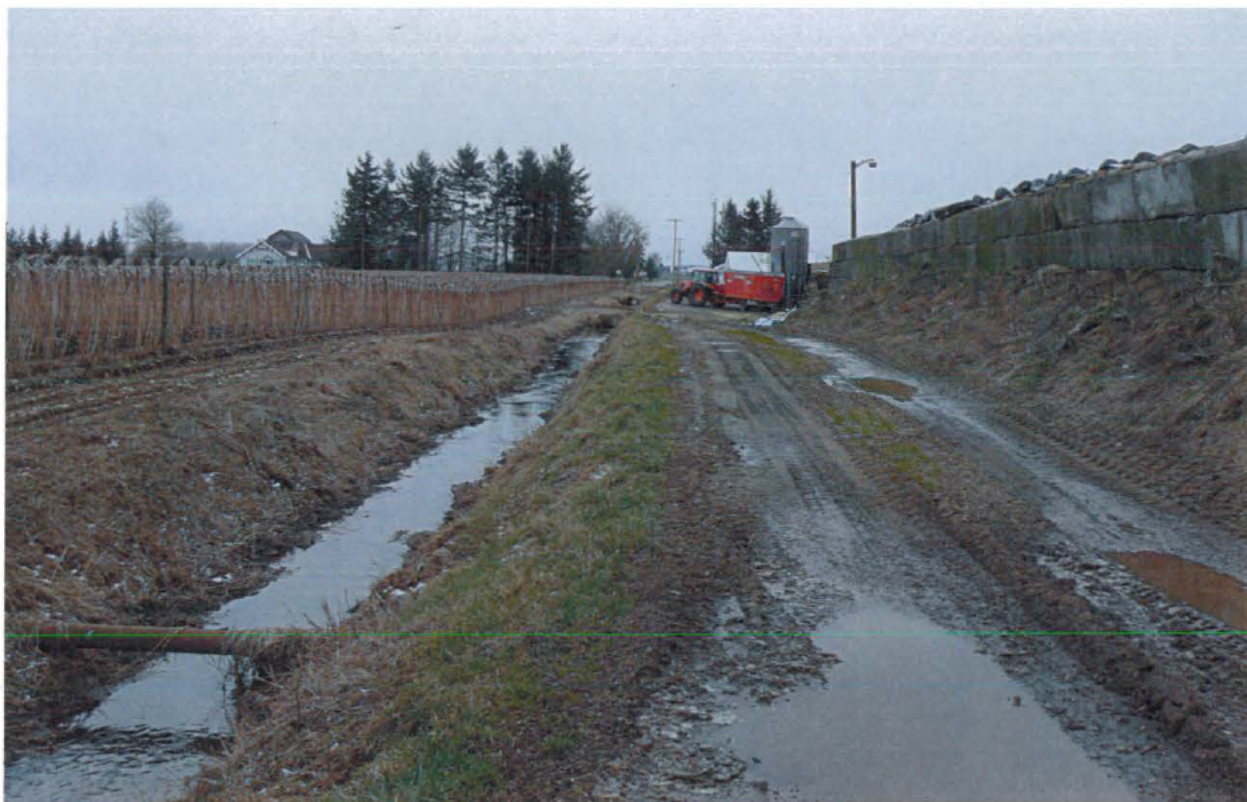
Photo 5. This is a picture of the drainage ditch adjacent to the Vander Haak I location. The wall on the right is where the feed storage is located.

others. This location is adjacent to an unnamed ditch that drains into Double Ditch and eventually into Fish Trap Creek. See photo 2 for the location of the unnamed ditch, and photos 5 and 6 for pictures of the feed storage area here and its proximity to the drainage ditch. All of the milkers (430) and 20 dry cows are confined at this location. The confinement areas are scraped into a 60,000 gallon pit 2-3 times daily. Manure from this pit is transported through an underground pipe to the digester at the Vander Haak II location (discussed more in Part C of this Section). The Vander Haak I lagoon is one of three that are used to store manure after it has been processed through the digester and solid separator at Vander Haak II, prior to land application.

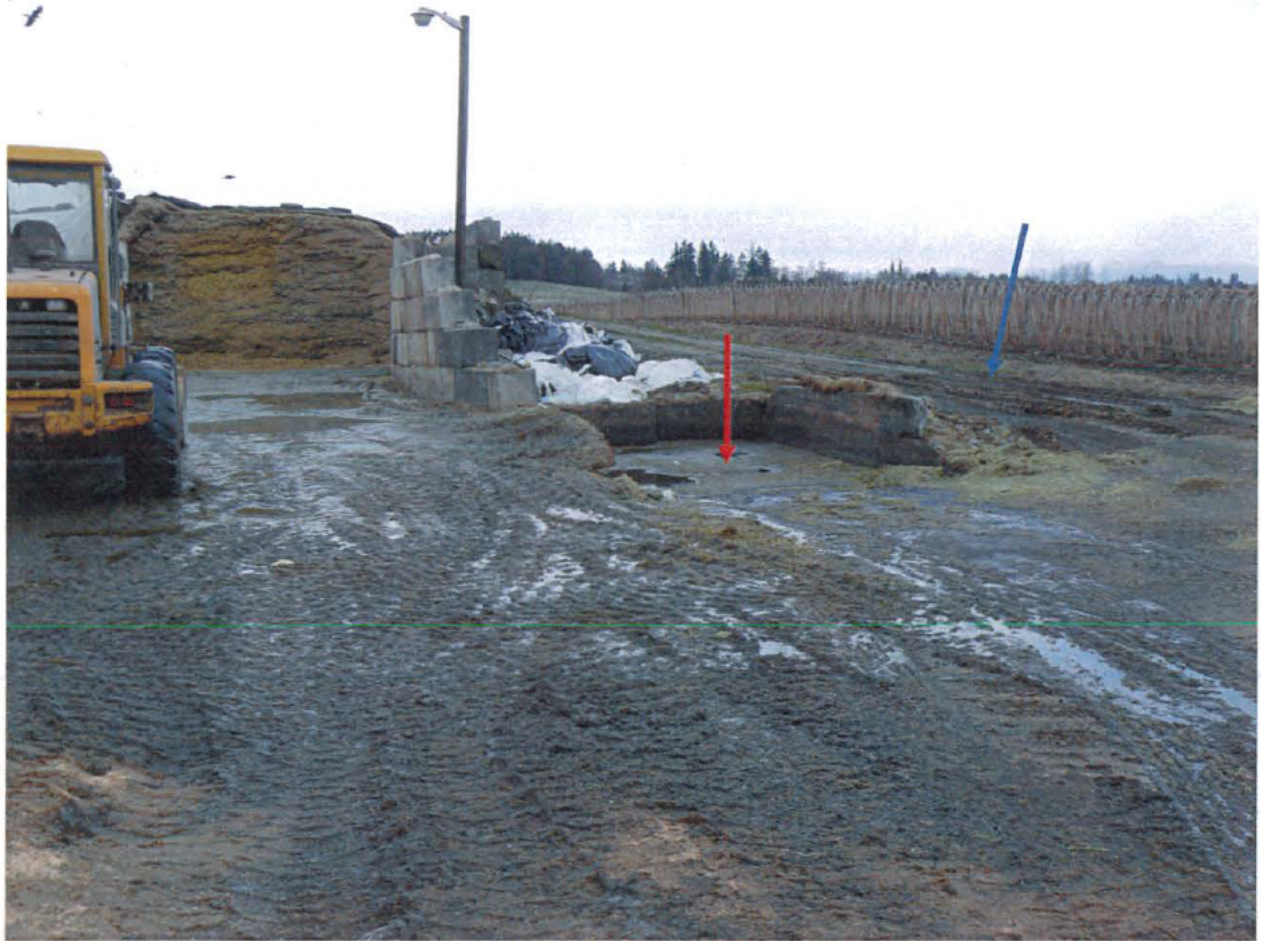
Photo 6. This picture illustrates the drainage system for the feed storage area at Vander Haak I. Any leachate drains into the low spot to the right of the feed (red arrow), where it is then pumped to the lagoon. The blue arrow indicates the location of the drainage ditch in Photo 5.
